ANGKOR VAT

INDIA'S CONTRIBUTION IN CONSERVATION

MEMOIRS OF THE
ARCHAEOLOGICAL SURVEY OF INDIA
NO. 91

B. NARASIMHAIAH

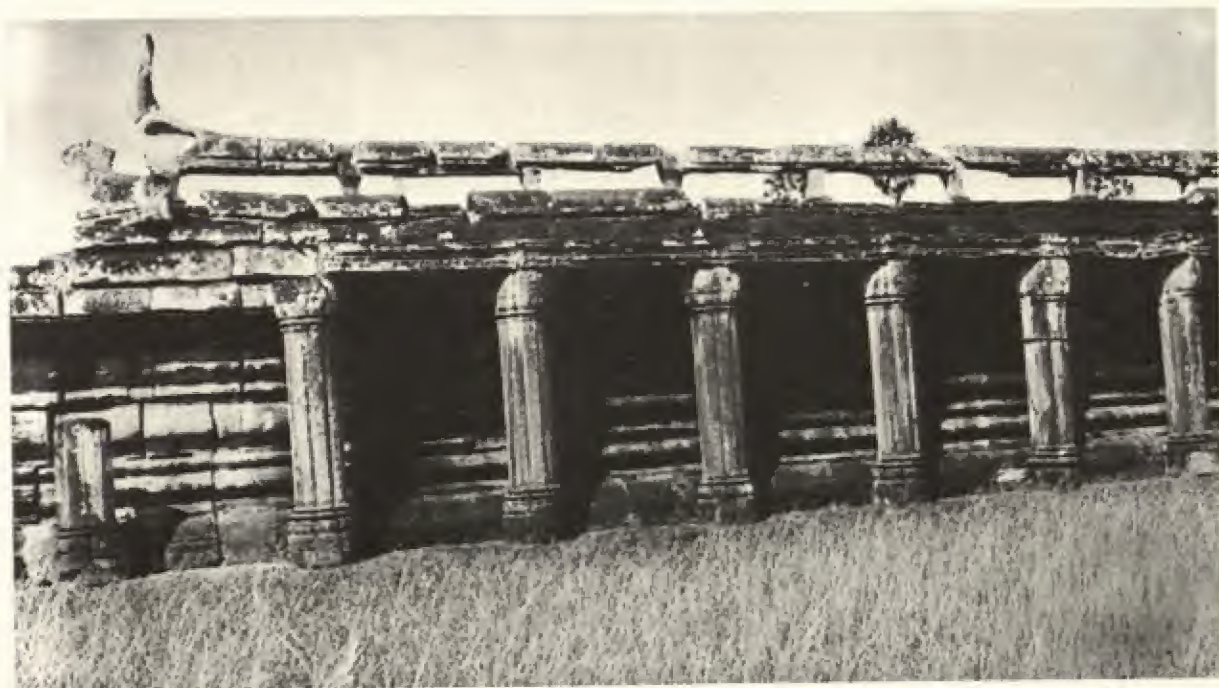
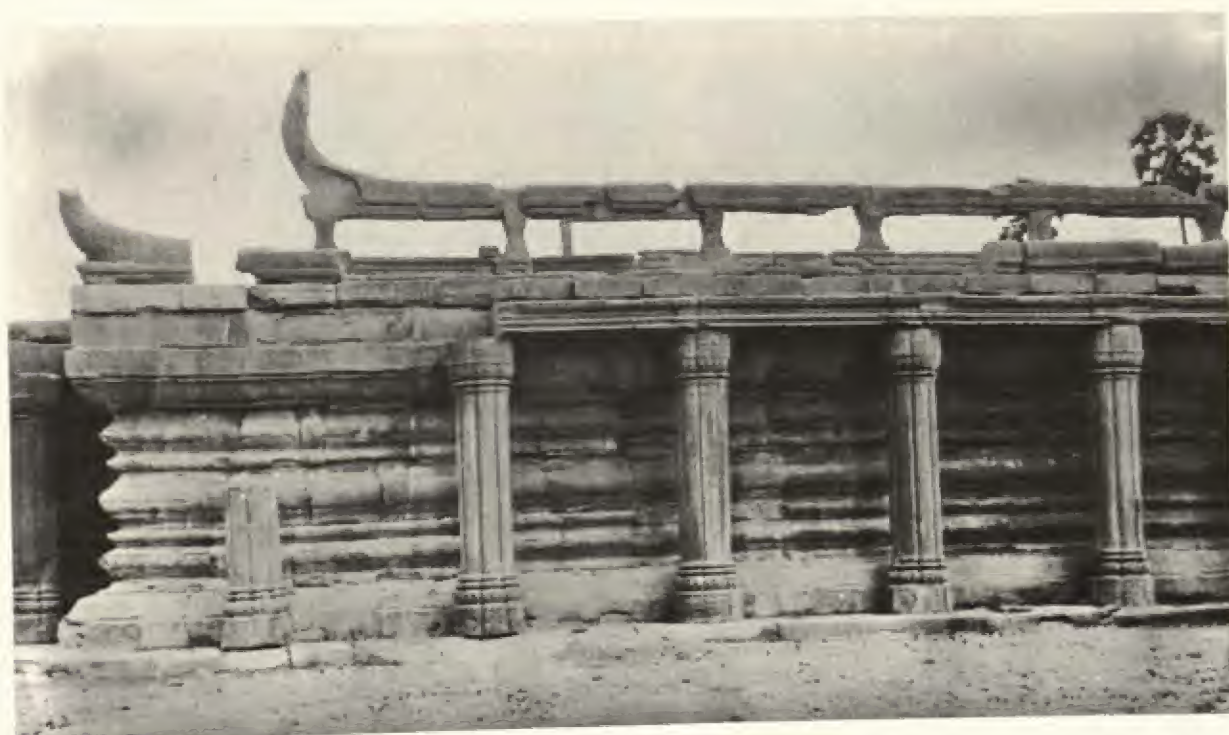
Esplanade (Ranga Mancha) : north-western portion, A, before and B, after conservation

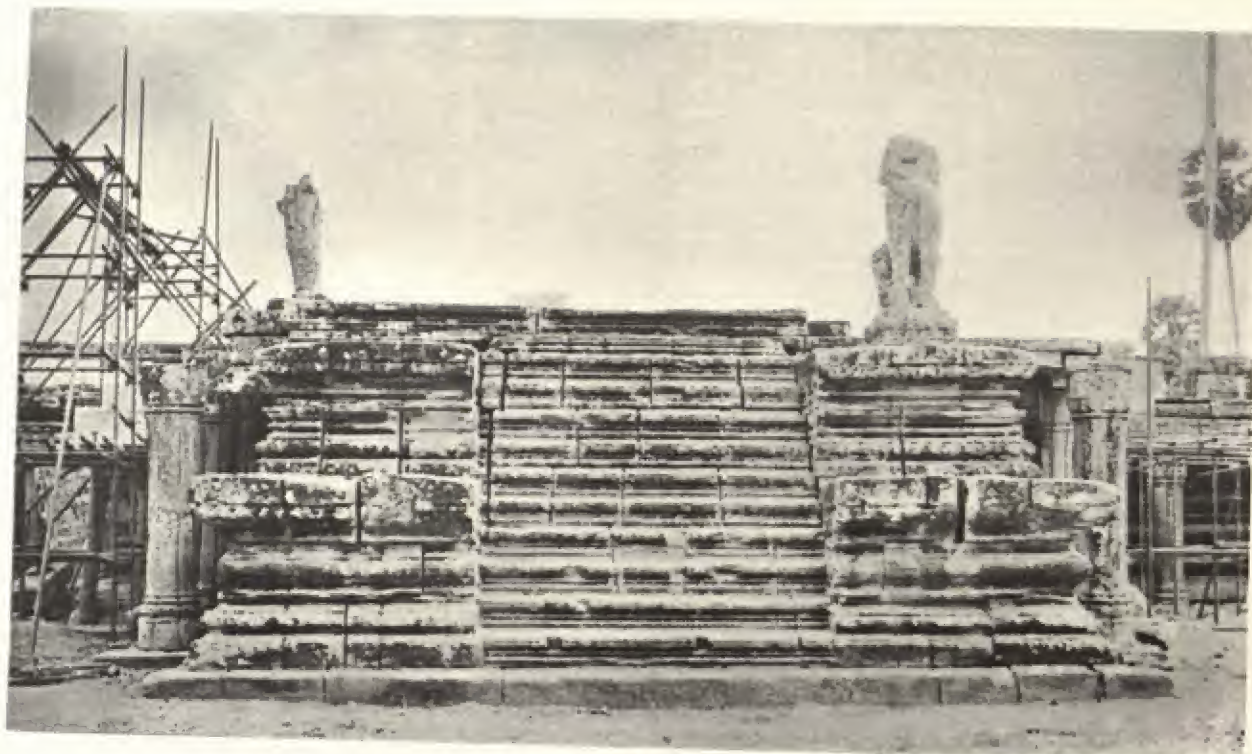
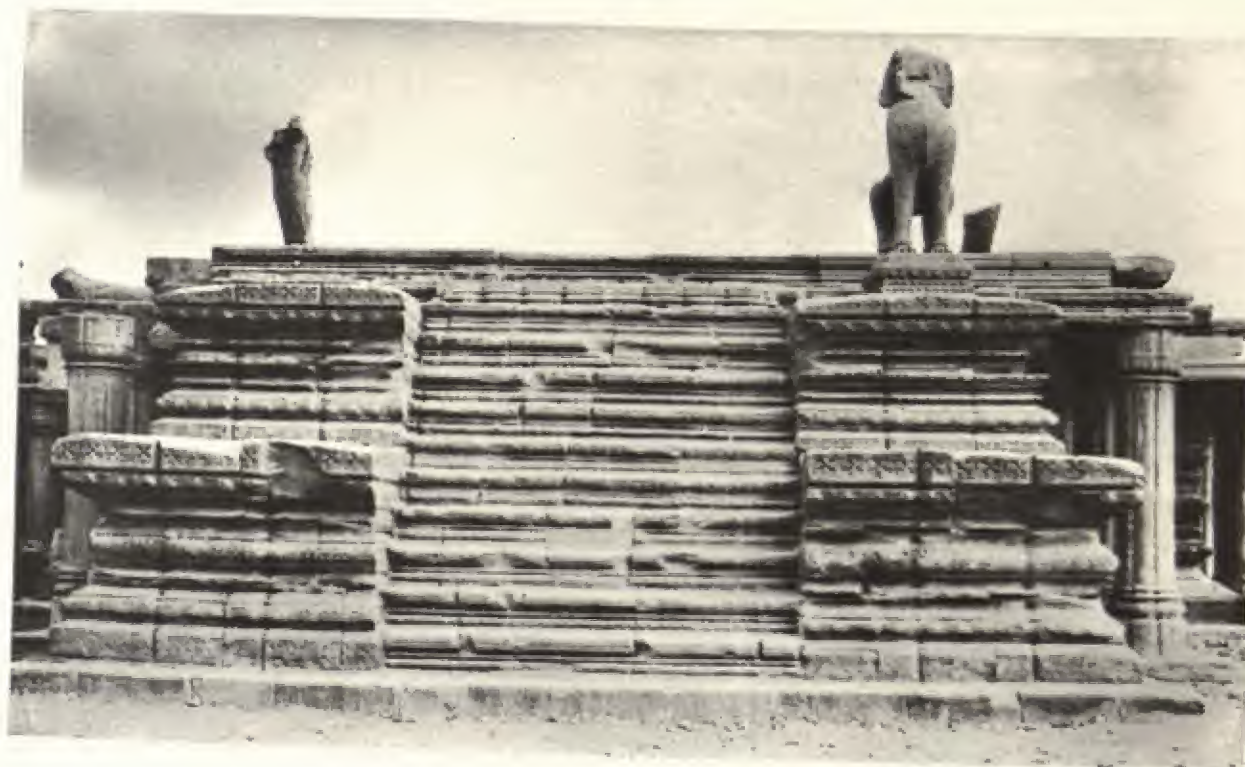
Esplanade (Ranga Mancha) : southern stepped entrance, A, before and B, after conservation

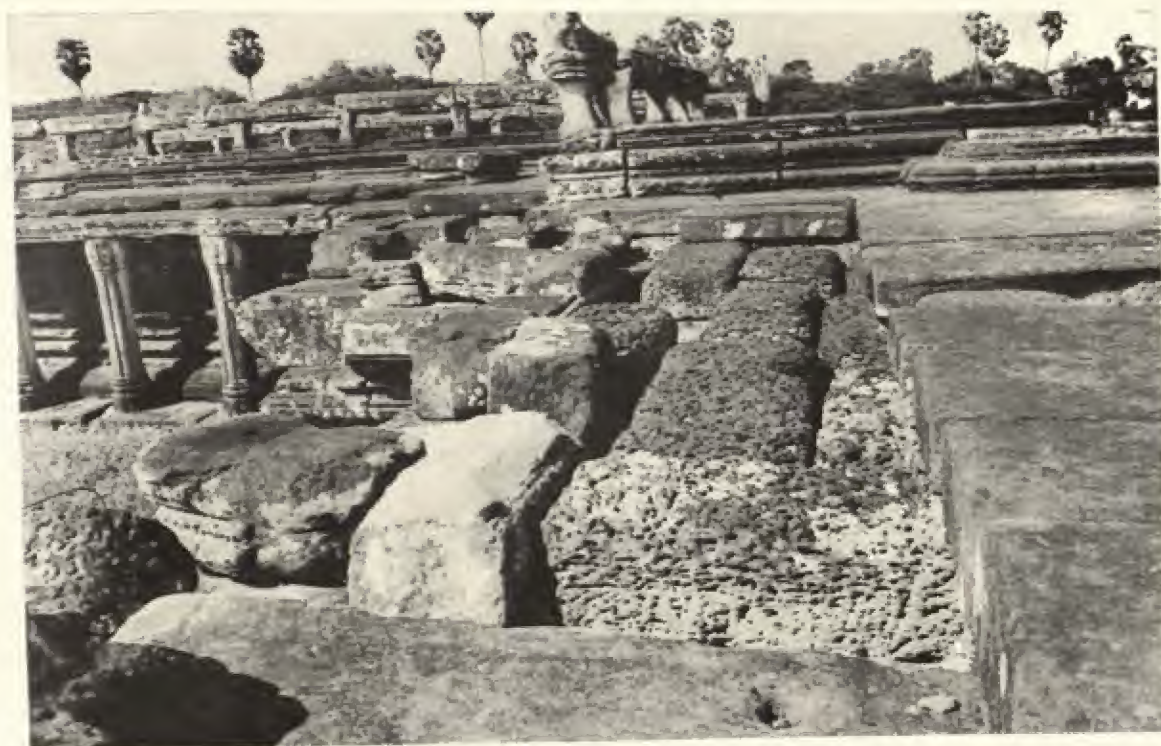
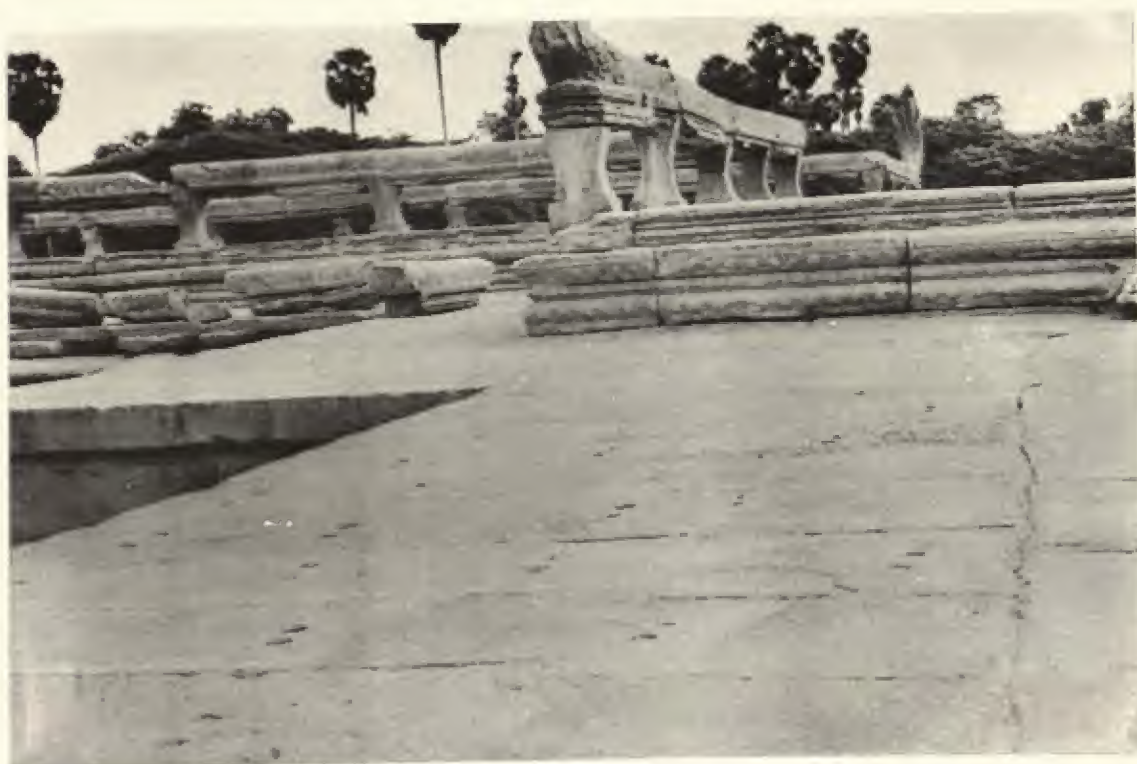
Esplanade (Ranga Mancha) : flooring, A, before and B, after conservation

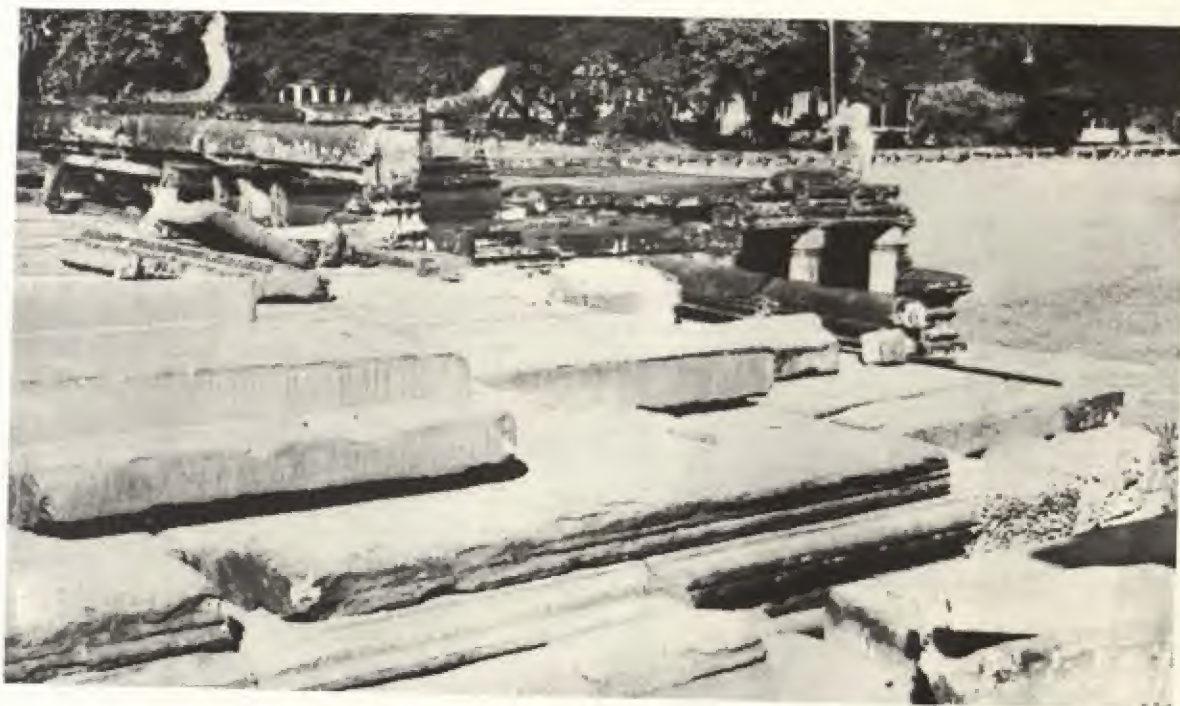
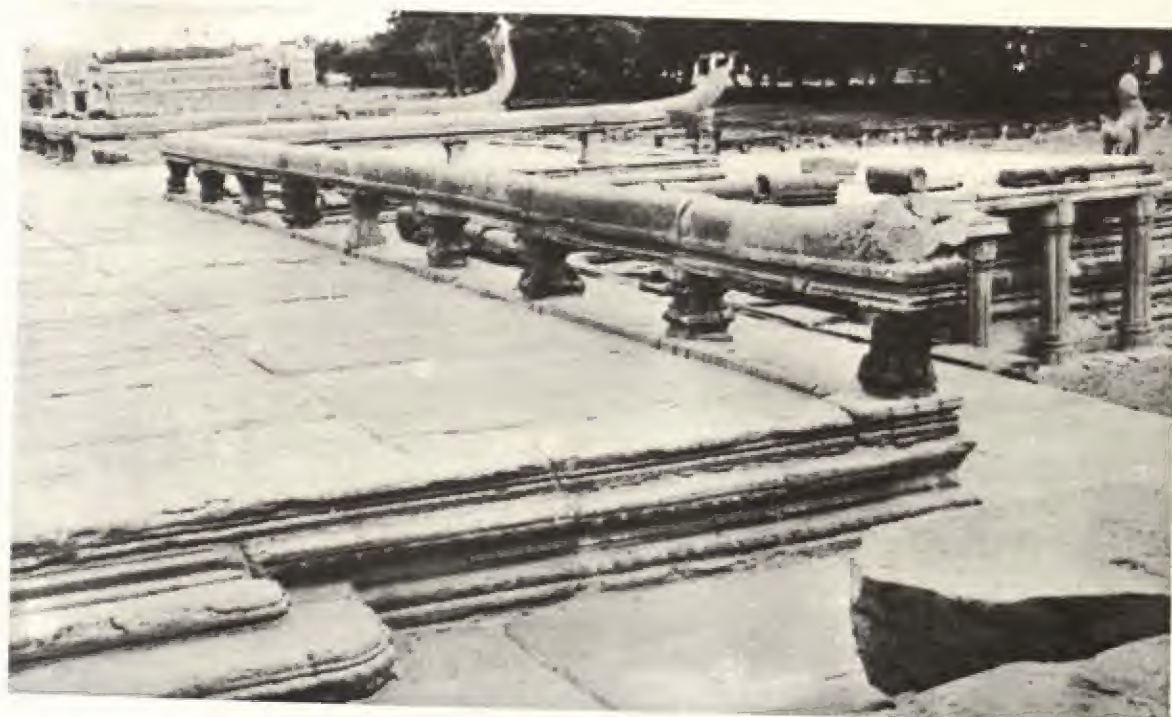
Esplanade (Ranga Mancha): flooring, A, before and B, after conservation

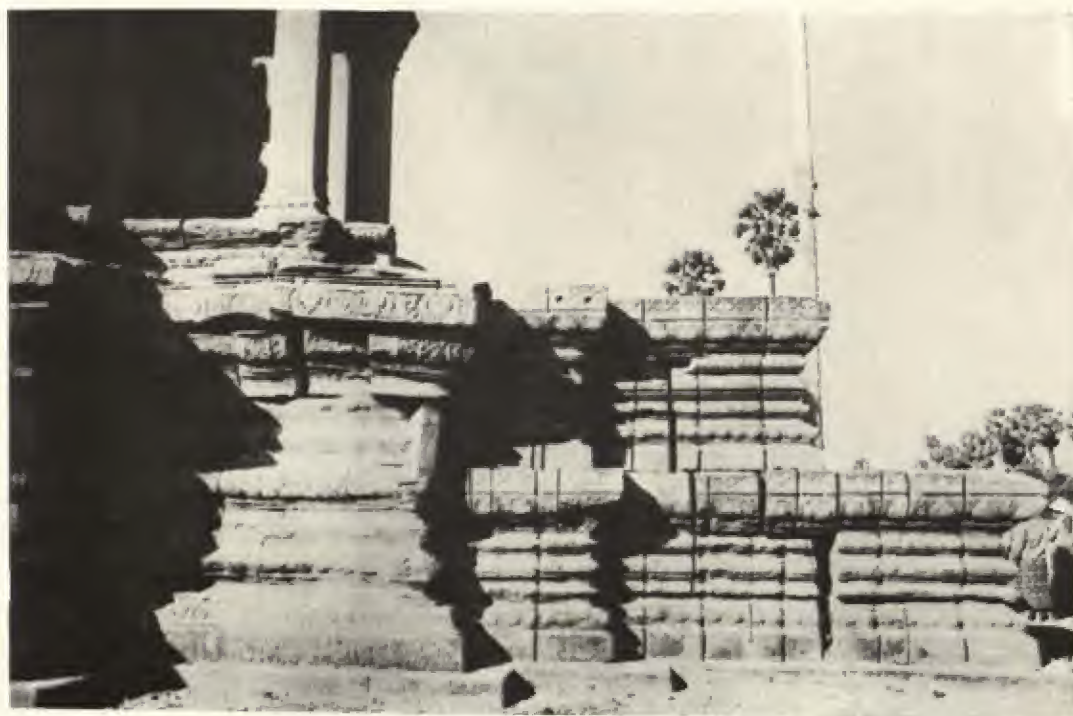
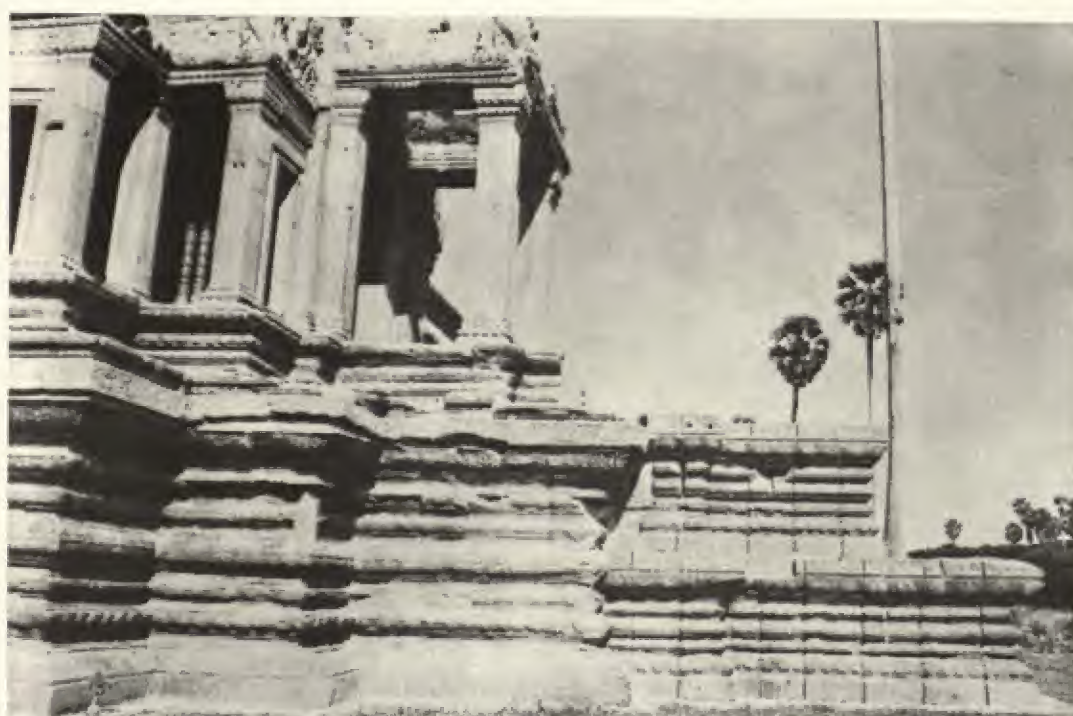
Third Enclosure : northern-central stepped entrance porch, A, before and B, after conservation

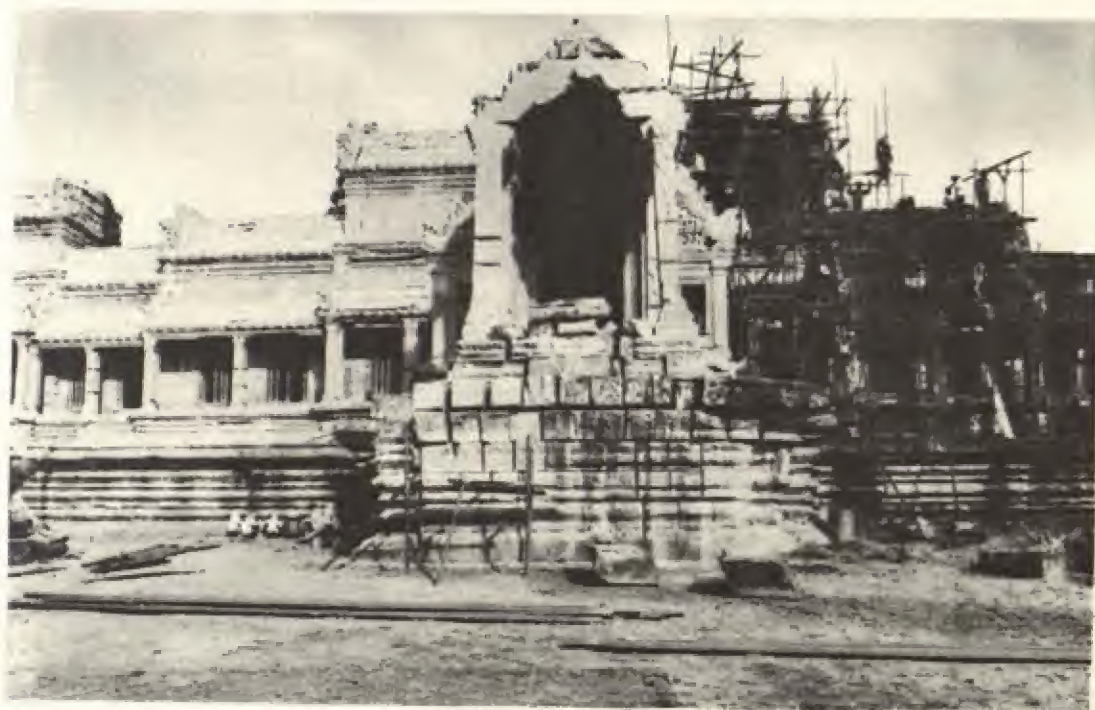
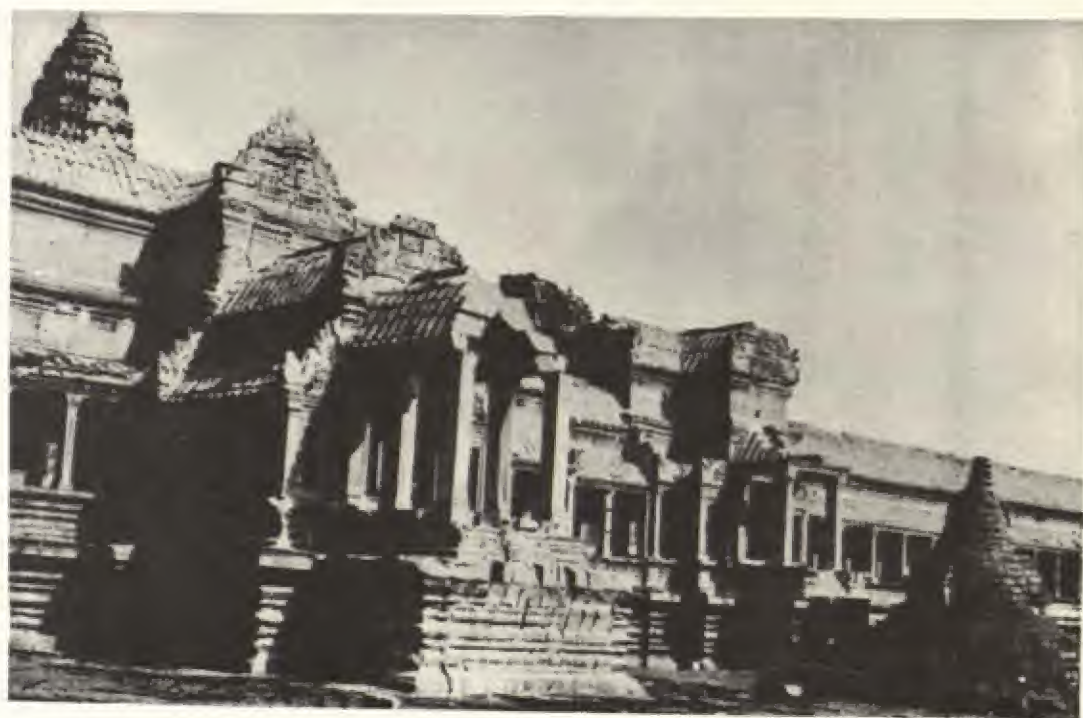
Third Enclosure : eastern-central entrance porch, A, before and B, after conservation

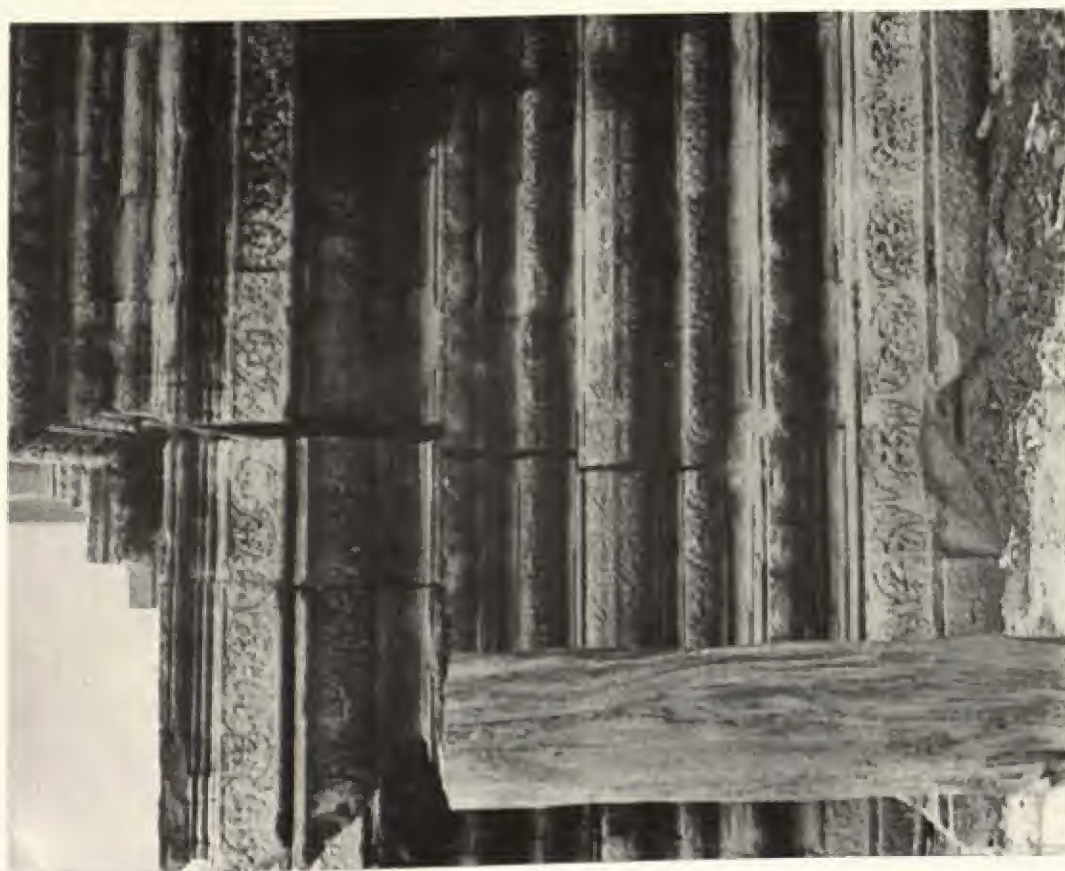
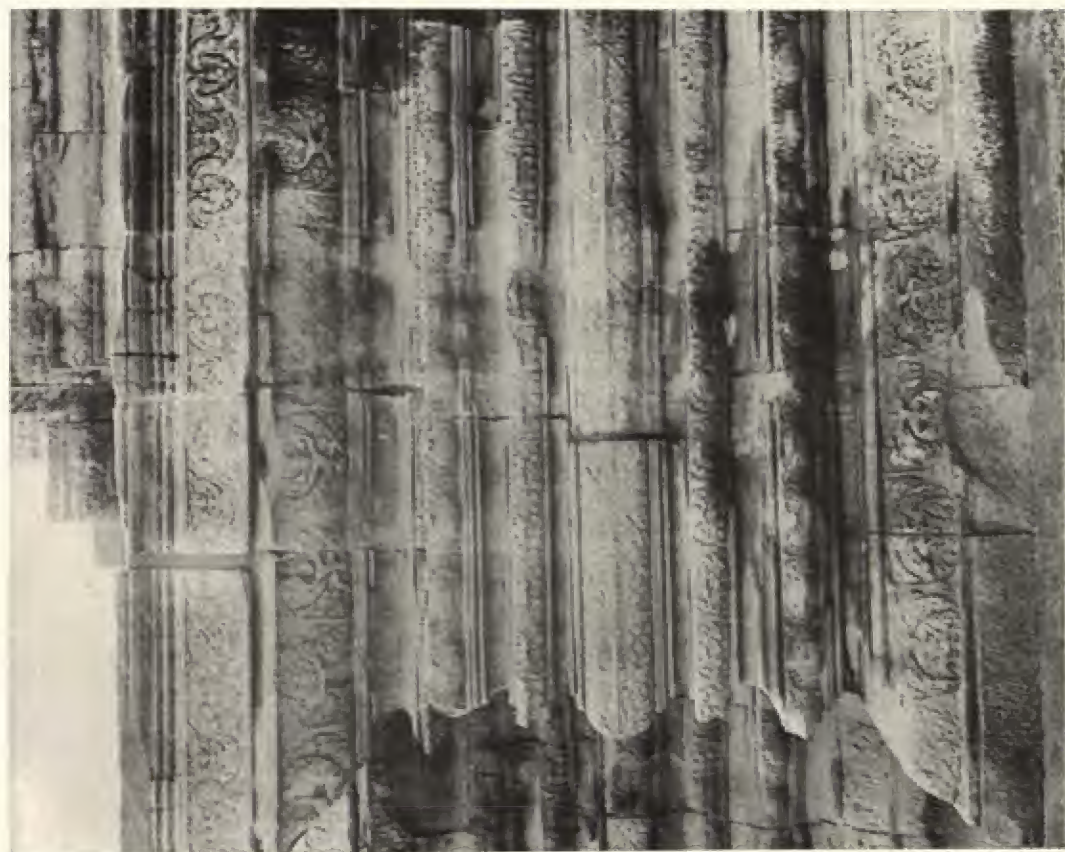
Third Enclosure : eastern-central entrance porch, A, before and B, after conservation

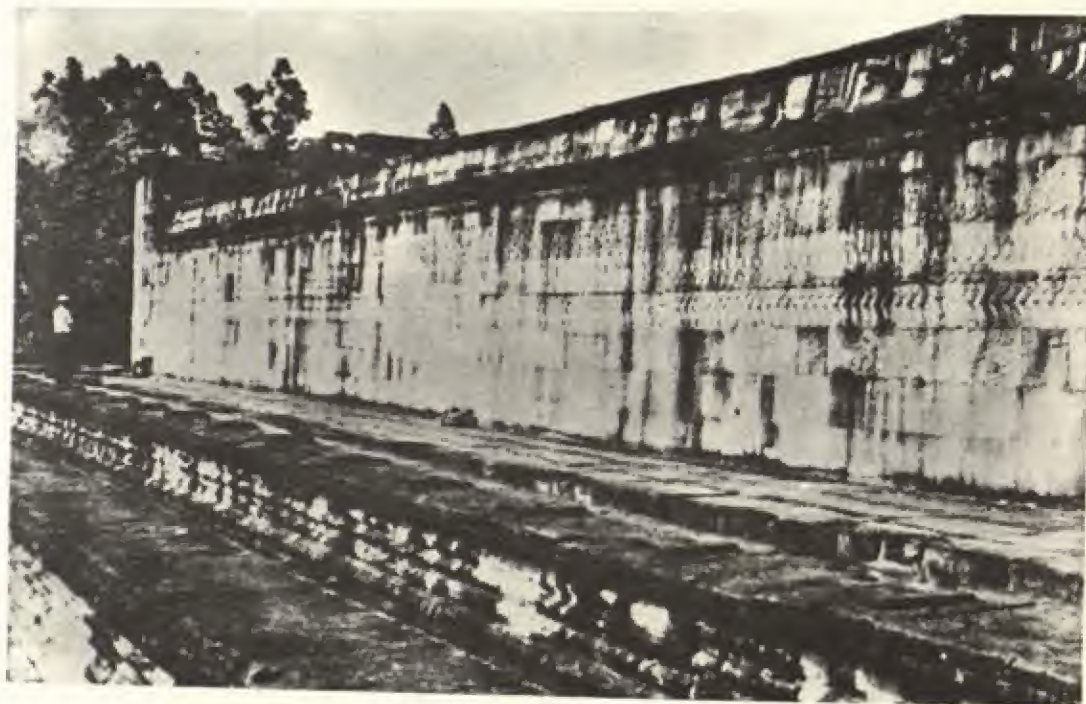
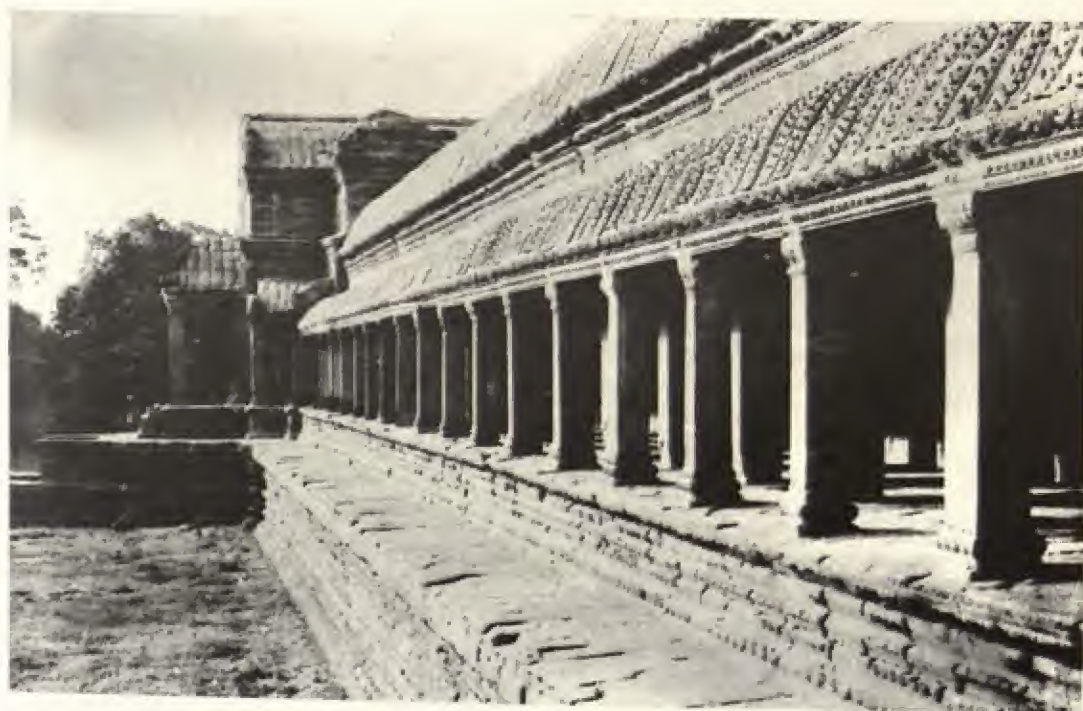
Third Enclosure : Southern Gallery on eastern side (Samudramanthuna Gallery). A, before and B, after conservation

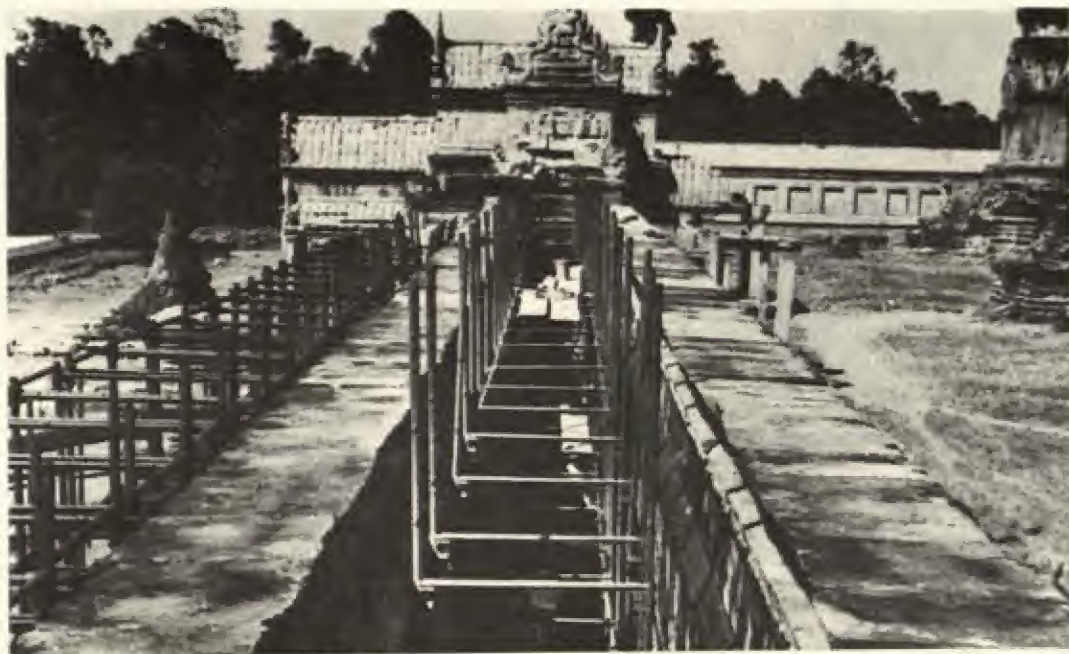
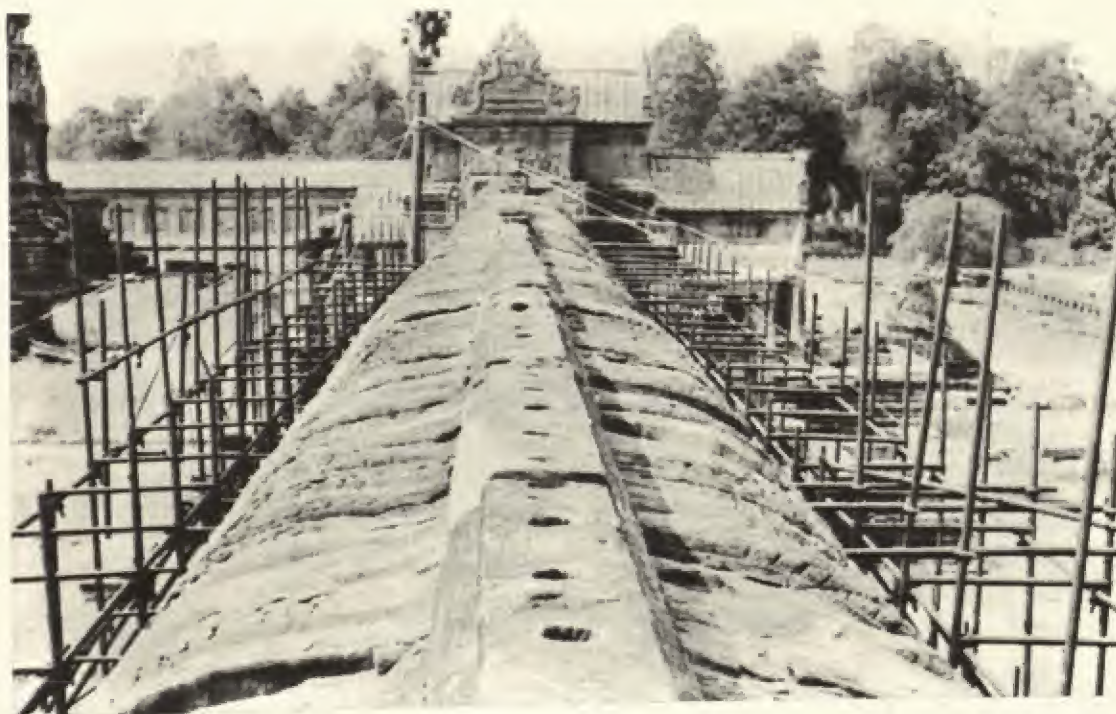
*Third Enclosure : Southern Gallery on eastern side (Samudramanthana Gallery), A, during
and B, after conservation*

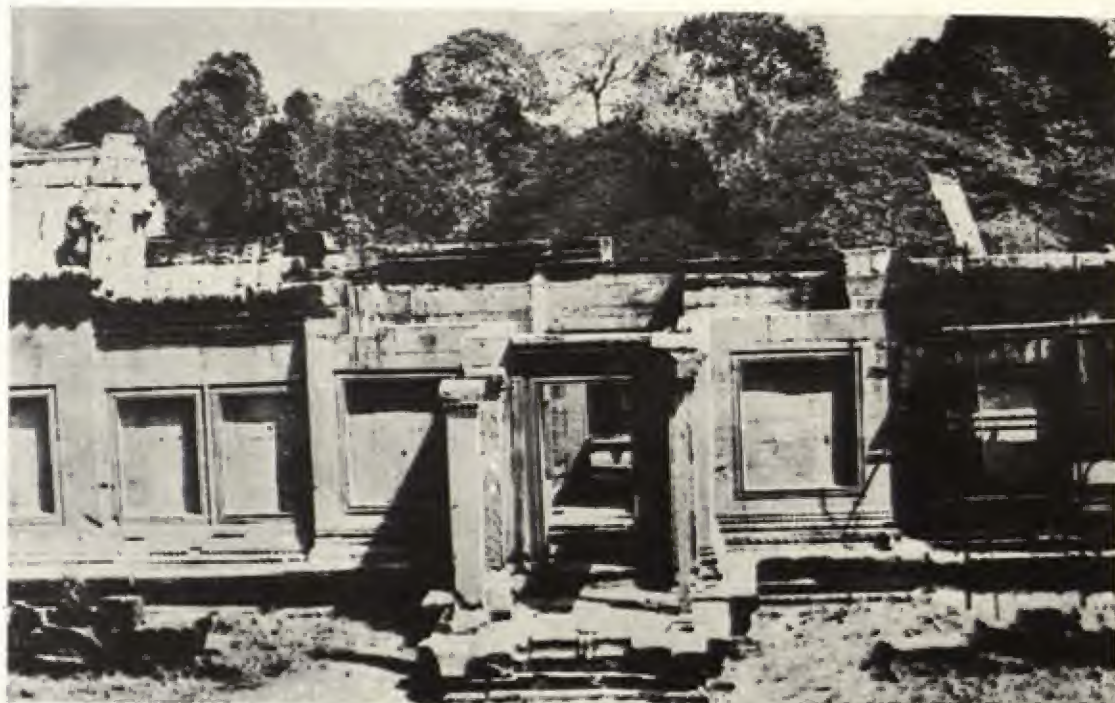
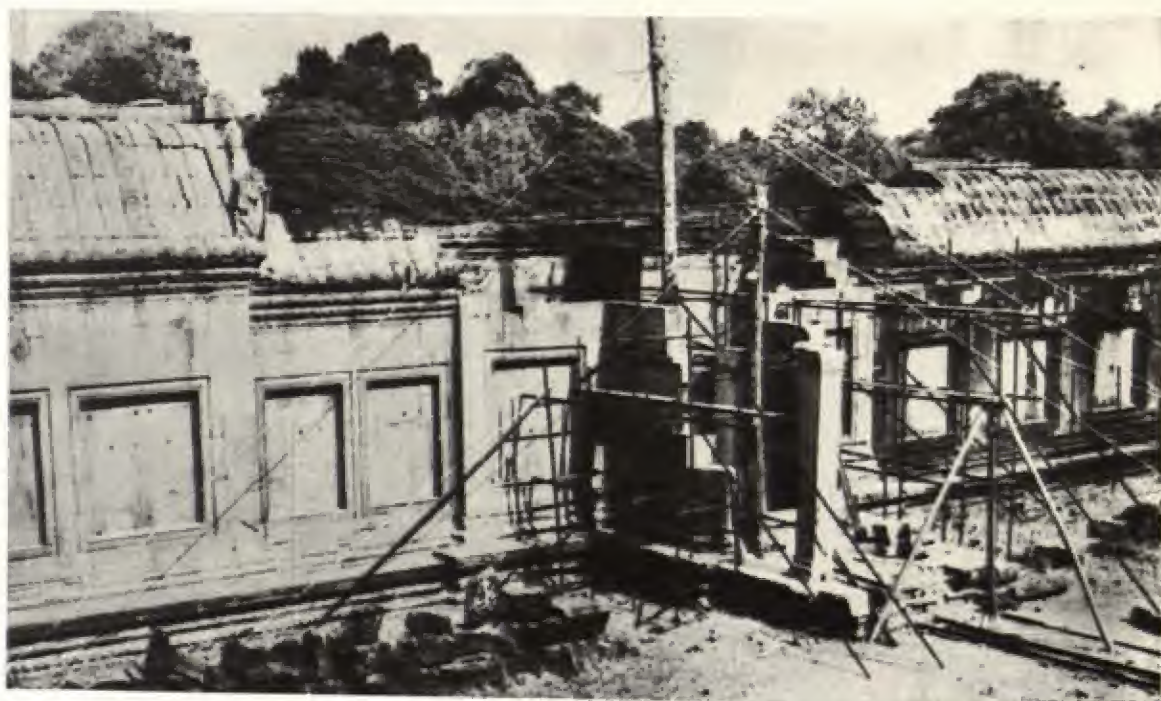
Third Enclosure : entrance pavilion north of Samudramanthana Gallery, A, before and B, during conservation

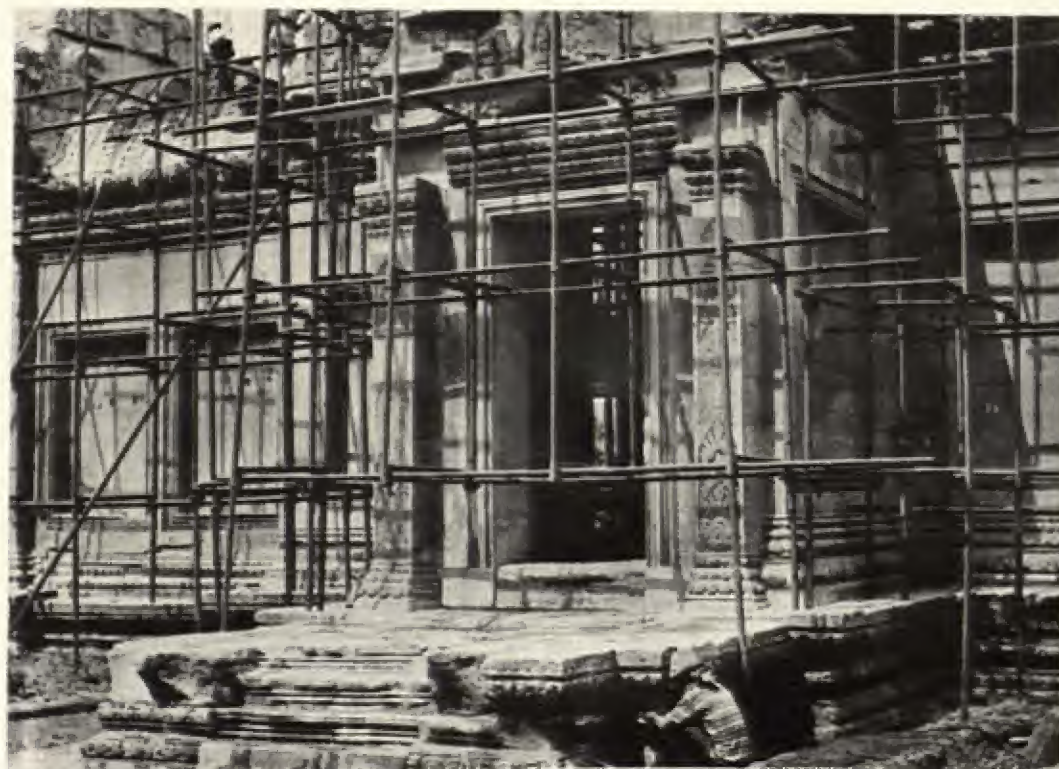
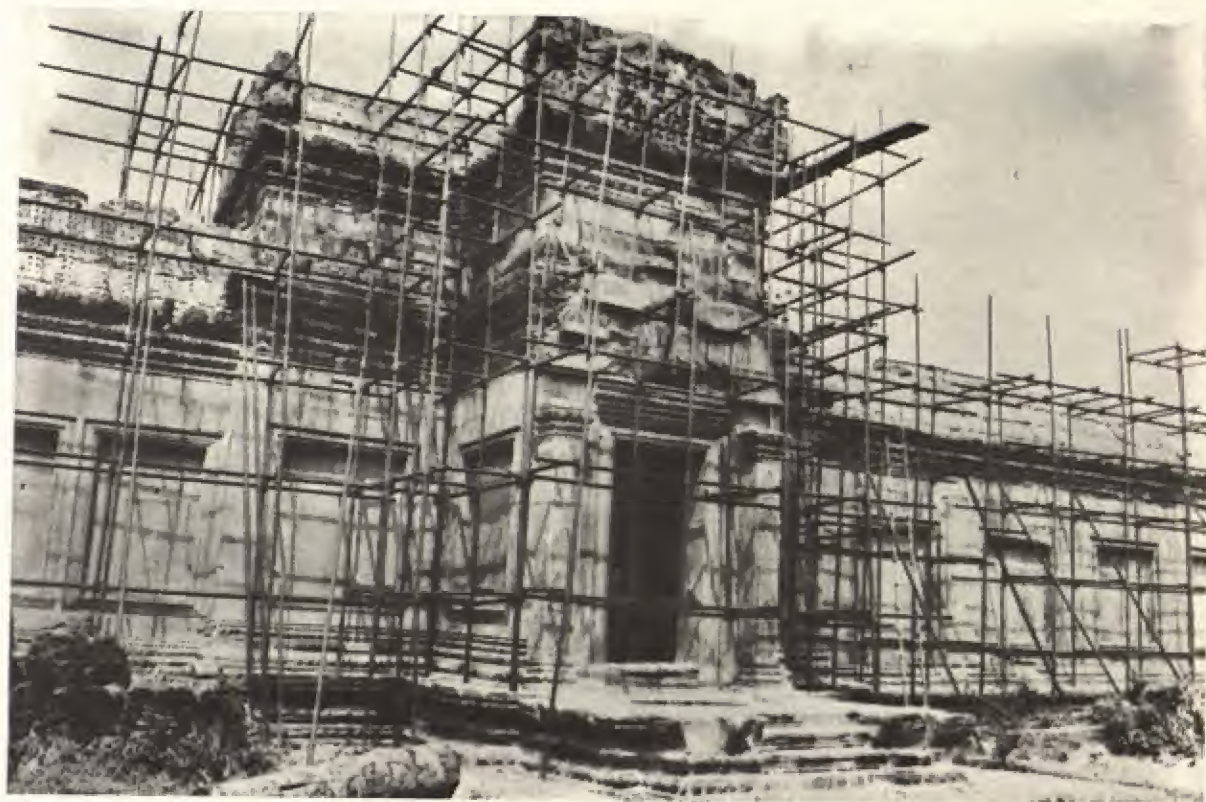
Third Enclosure : entrance pavilion north of Samudramanthana Gallery, during conservation

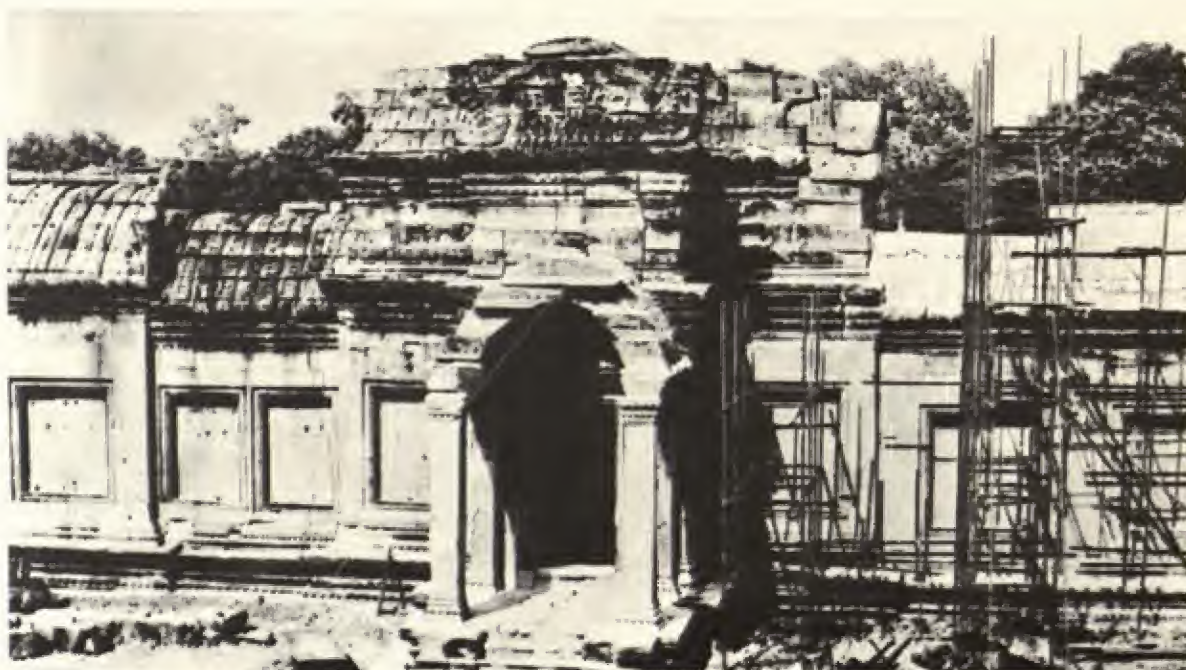
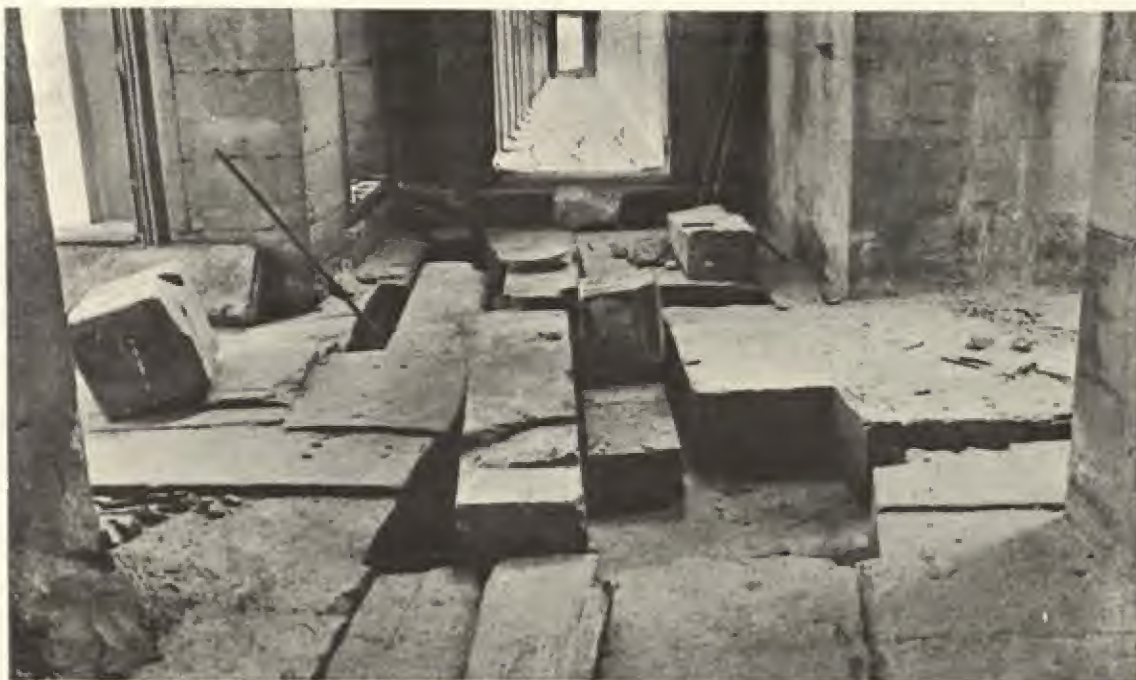
Third Enclosure : entrance pavilion north of Samudramanthana Gallery, A, during and B, after conservation

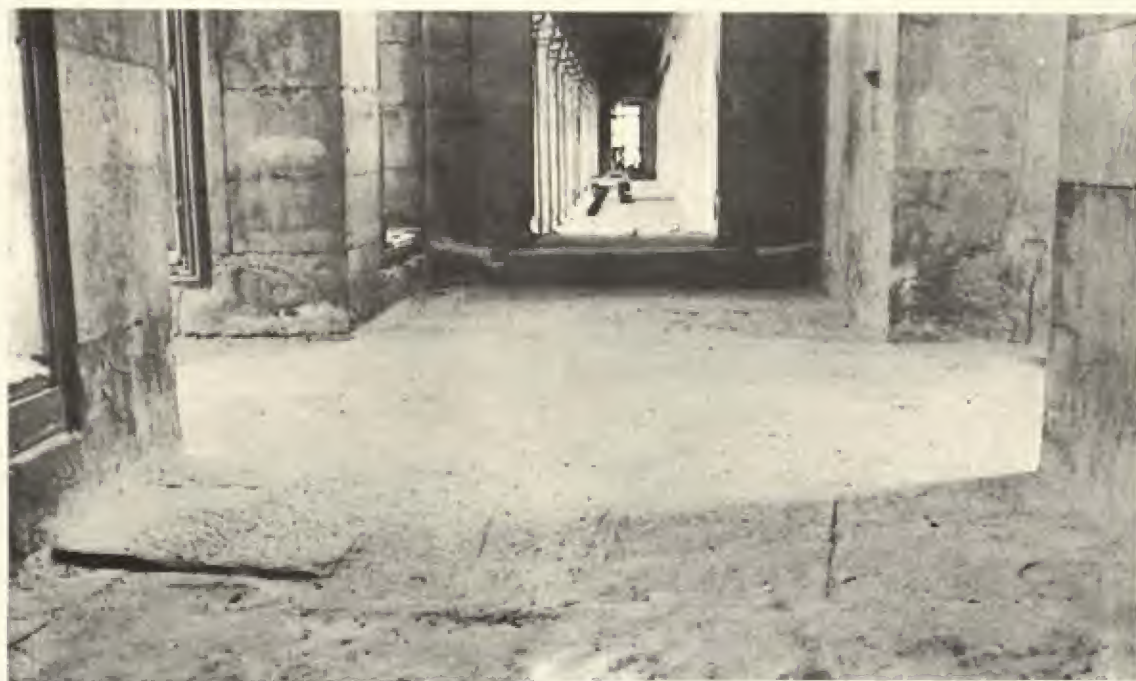
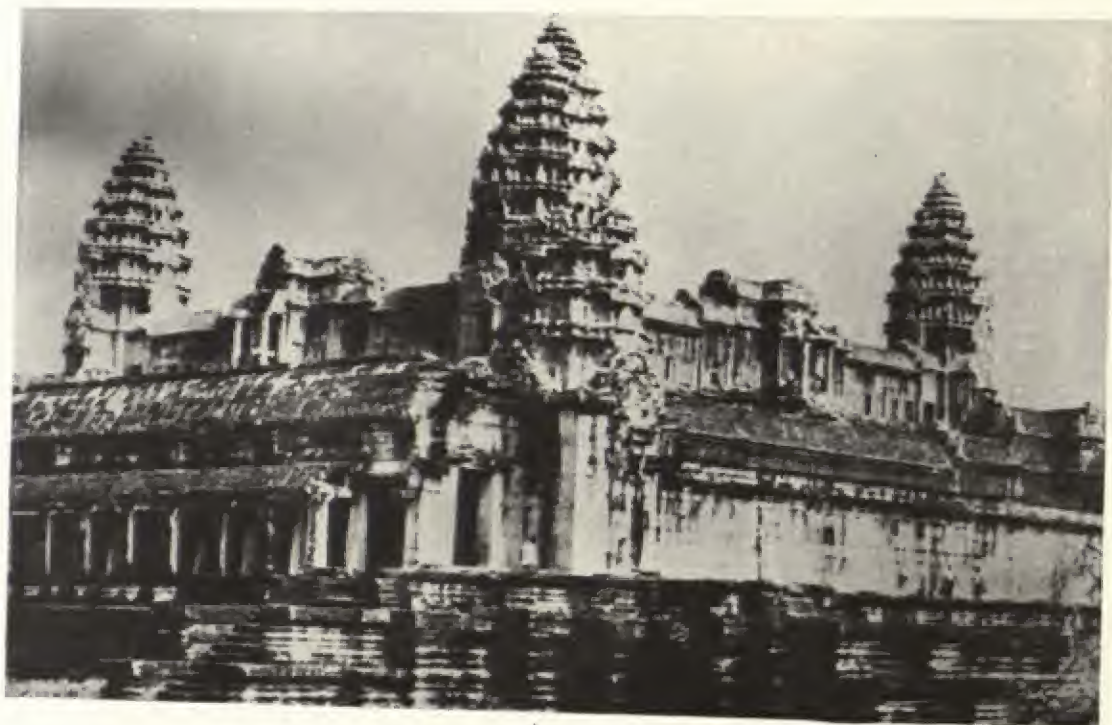
Third Enclosure : flooring, entrance pavilion, A, before and B, after conservation
